RADIOACTIVE DECONTAMINATION OF THE FORMER CSIRO APPLIED ORGANIC CHEMISTRY
DIVISION LORIMER STREET FISHERMENS BEND

29 March, 1990

Owen J. Wilson

Australian Radiation Laboratory

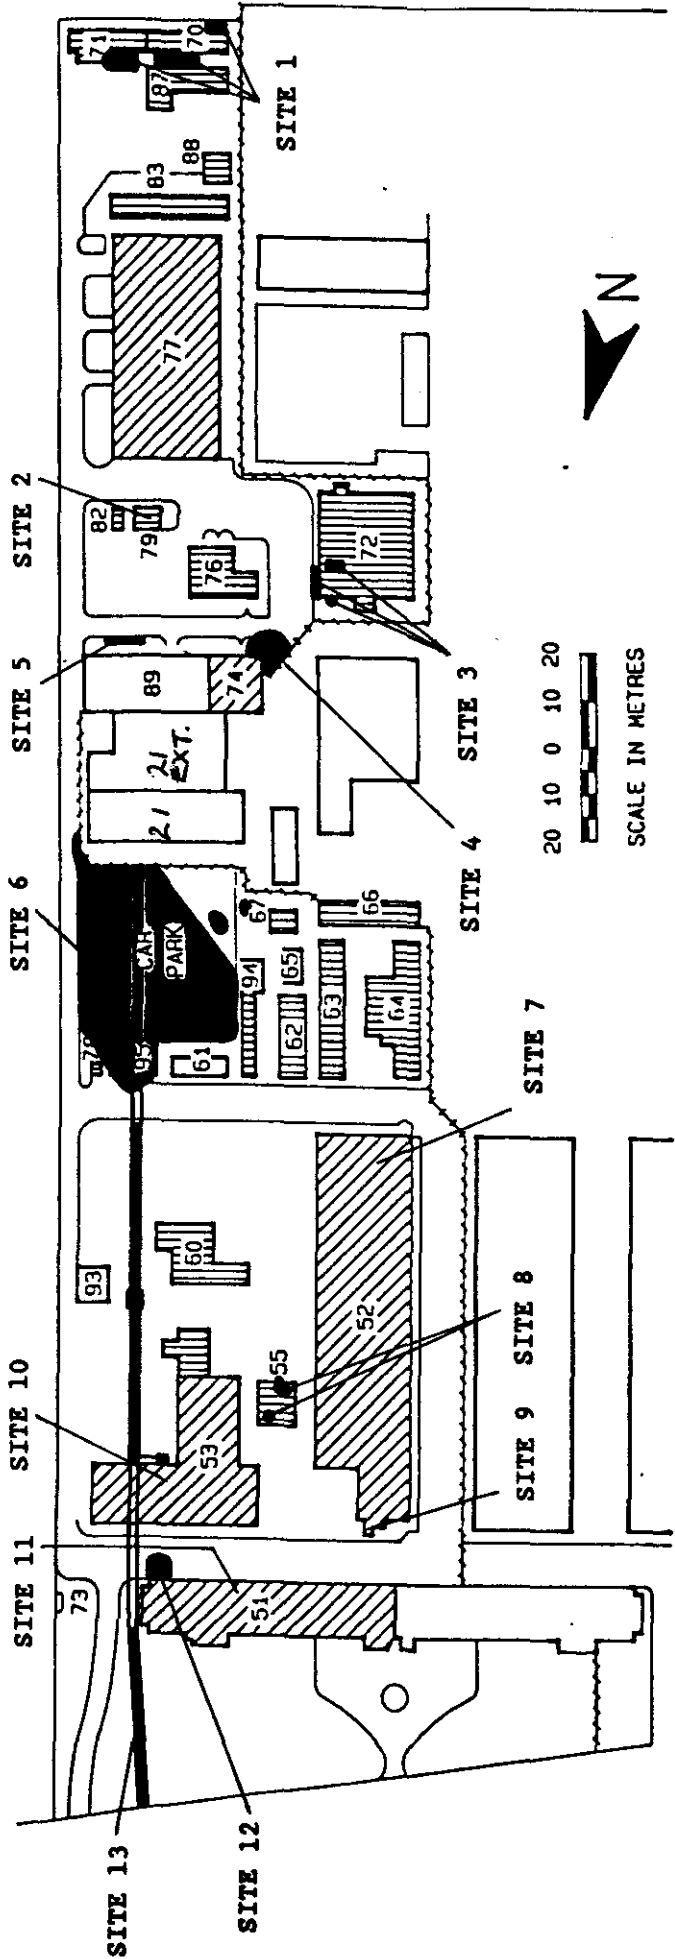
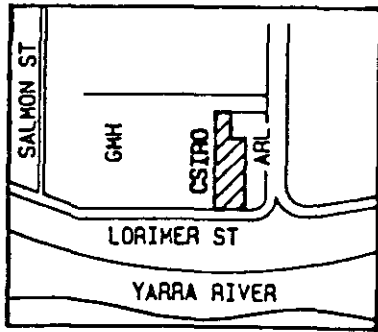
Annex 1: Property Diagram CSIRO Fishermens Bend

Significant levels of radioactivity were detected at various sites on the property.[2,4] On excavation, the true extent of these finds was revealed. The site positions (numbered in order from the back of the property to the front), and the approximate areas of the excavations are given on the property diagram, see Annex 1.
