20
University Premium

19 August 1979

— to —

18 January 1980

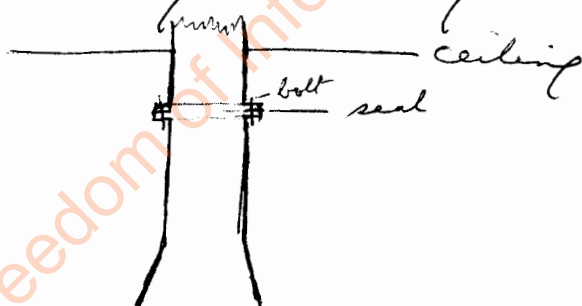
- Removed ducting in Ra. repair room by undoing bolts holding ducting at flange.
- Sealed both ends of ducting removed - covered with heavy duty plastic & used tape to hold.
- Cleaned any dust from inside remaining ducting using vacuum cleaner extension - cleaned to just above ceiling. (Wore respirator for this).
- Sealed end of remaining ducting by covering with heavy duty plastic & used tape to seal 3 accessible sides.
- Used vacuum cleaner to remove all dust on wall behind ducting removed. (Also removed dust on floor of room.)

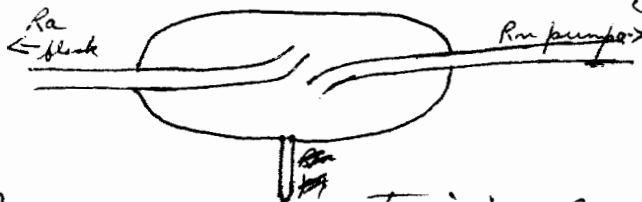
A/ Dismantled Ra pump, from top downwards.
Glass parts put in drum & broken up.
All framework above the pump removed.
Glass tube leading to strongroom removed.
(this contained some mercury)
The line included a glass 'trap'

This was 'active': 3 mR/h.

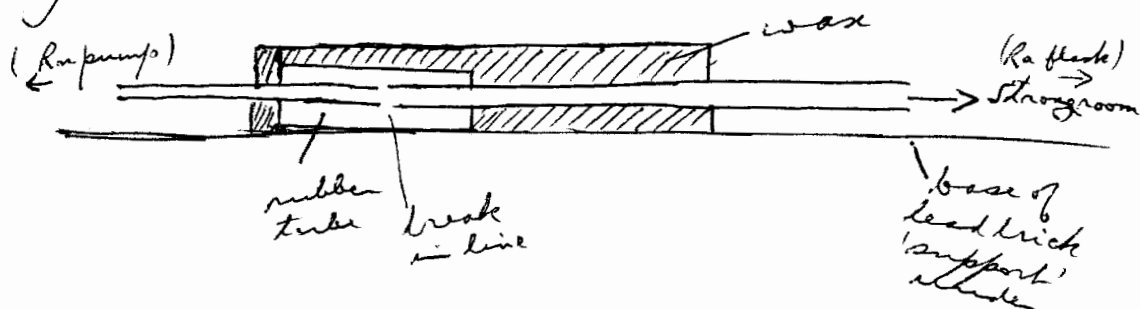
Also line appeared to have been
joined at some time:

Found easiest to break glass tubes using
file - cut 'inch's break same way. Few
failures.
