COMMONWEALTH DEPARTMENT OF COMMUNITY SERVICES
AND HEALTH

Australian Radiation Laboratory

Tietkens Plain Karst - Maralinga

ARL/TR081
ISSN 0157-1400
SEPTEMBER 1988

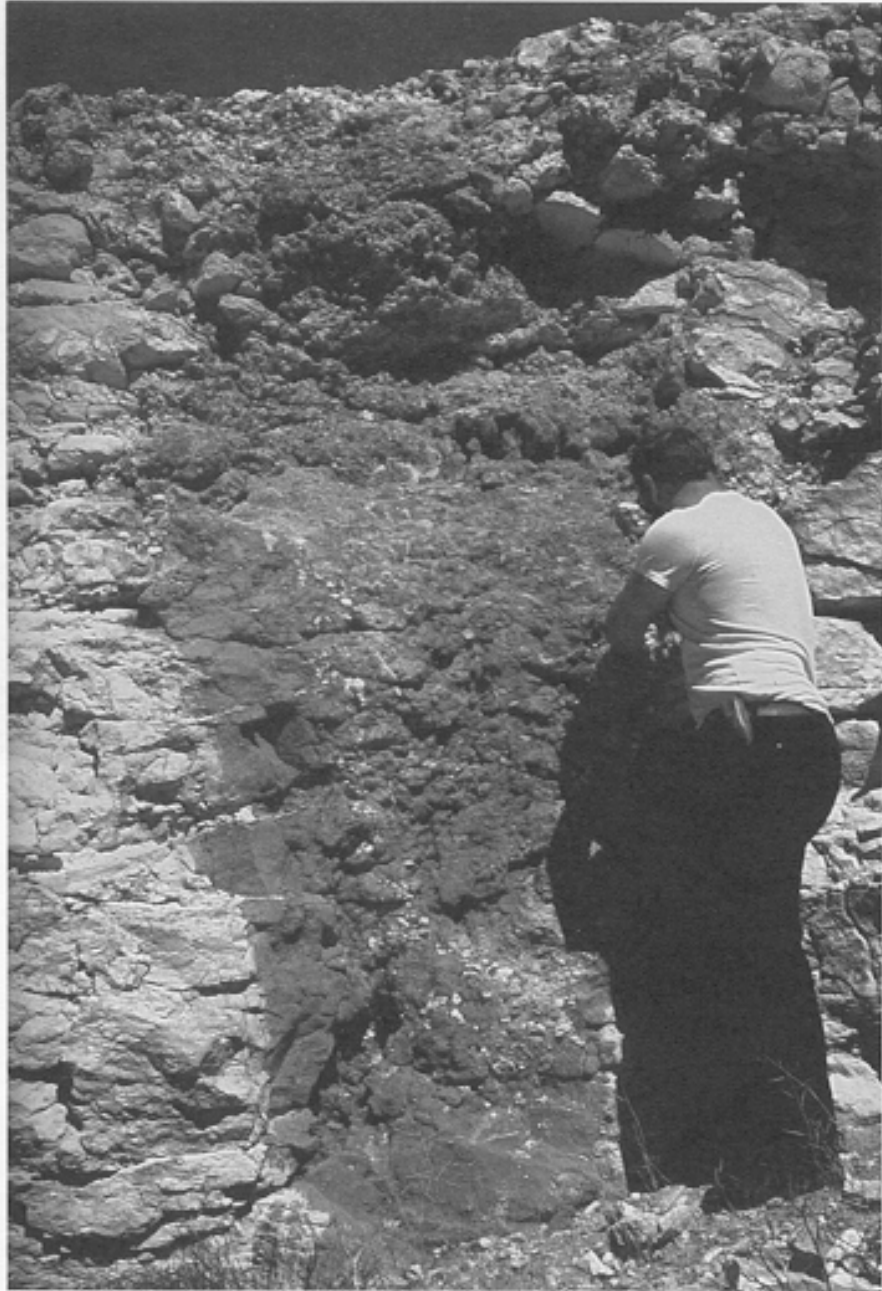
Plate 1. Cavity filled with earth in Roadside Quarry

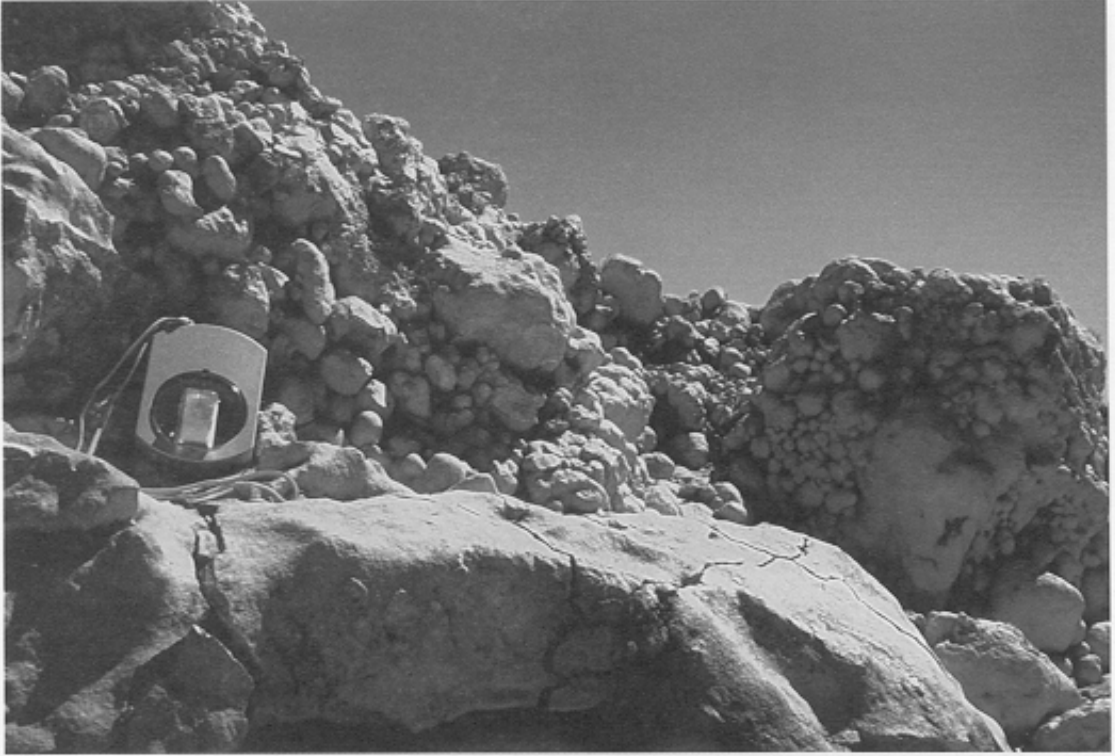
Plate 2. Calcrete nodules and calcrete sheets in Roadside Quarry

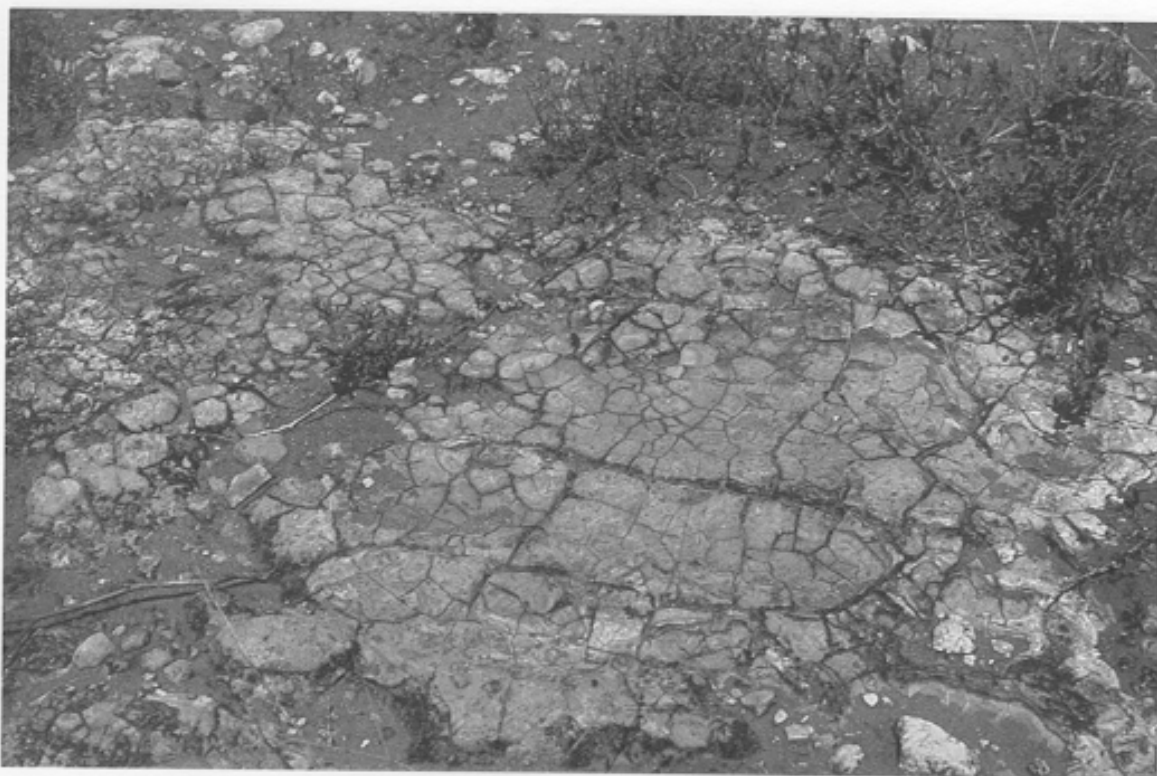
Plate 3. Multiple fracturing of the indurated carbonate rock surface at Yadina Rockhole

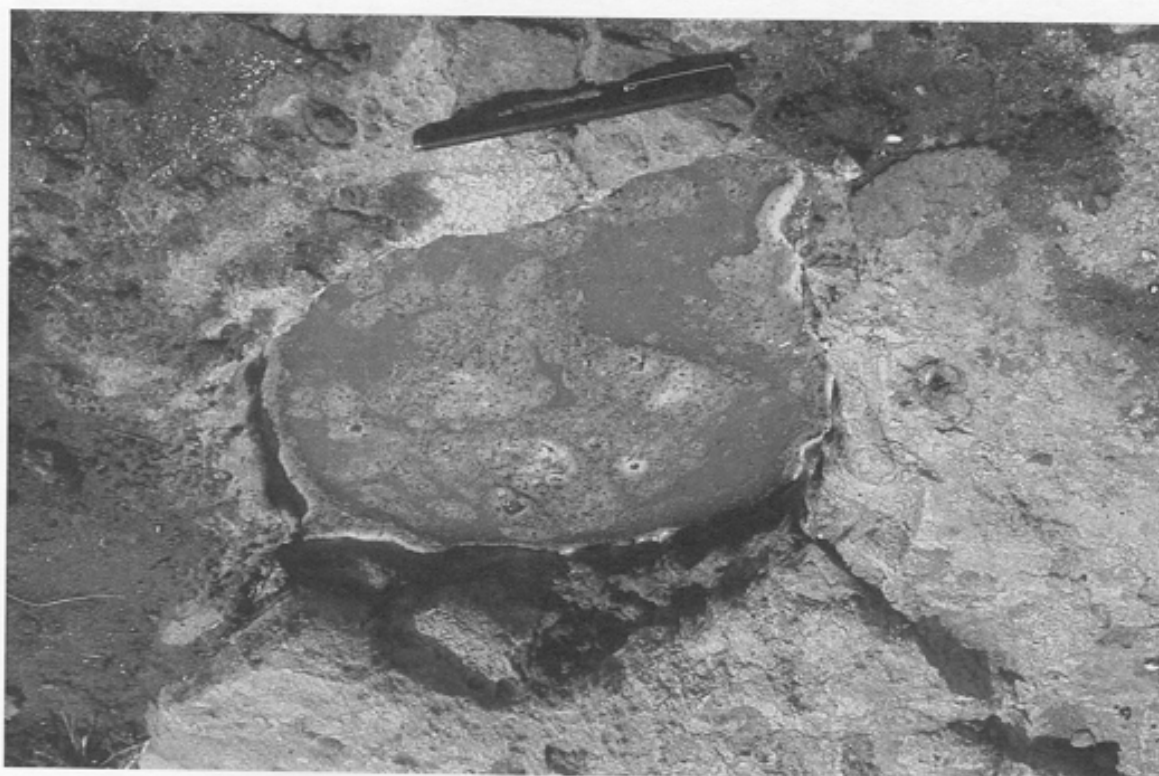
Plate 4. Solution pan without vegetation at Yadina Rockhole

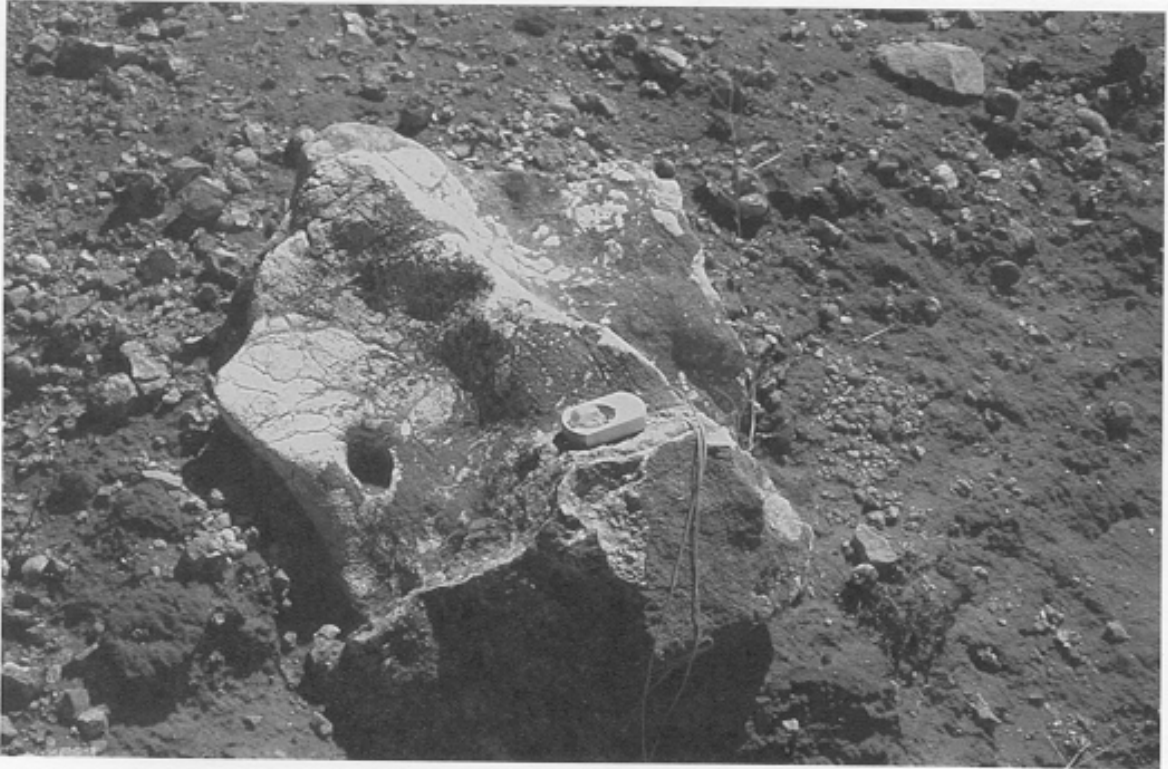
Plate 5. Subsoil weathering of a dolomite boulder

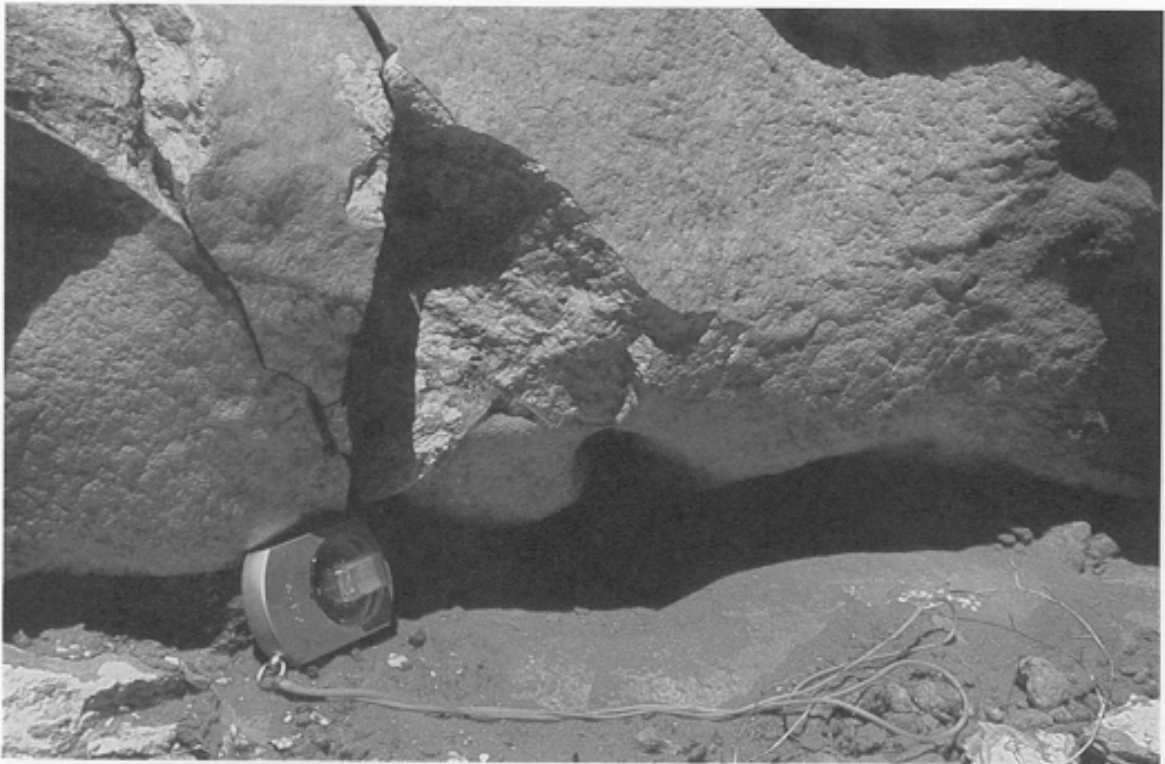
Plate 6. A dolomite boulder with an unweathered surface

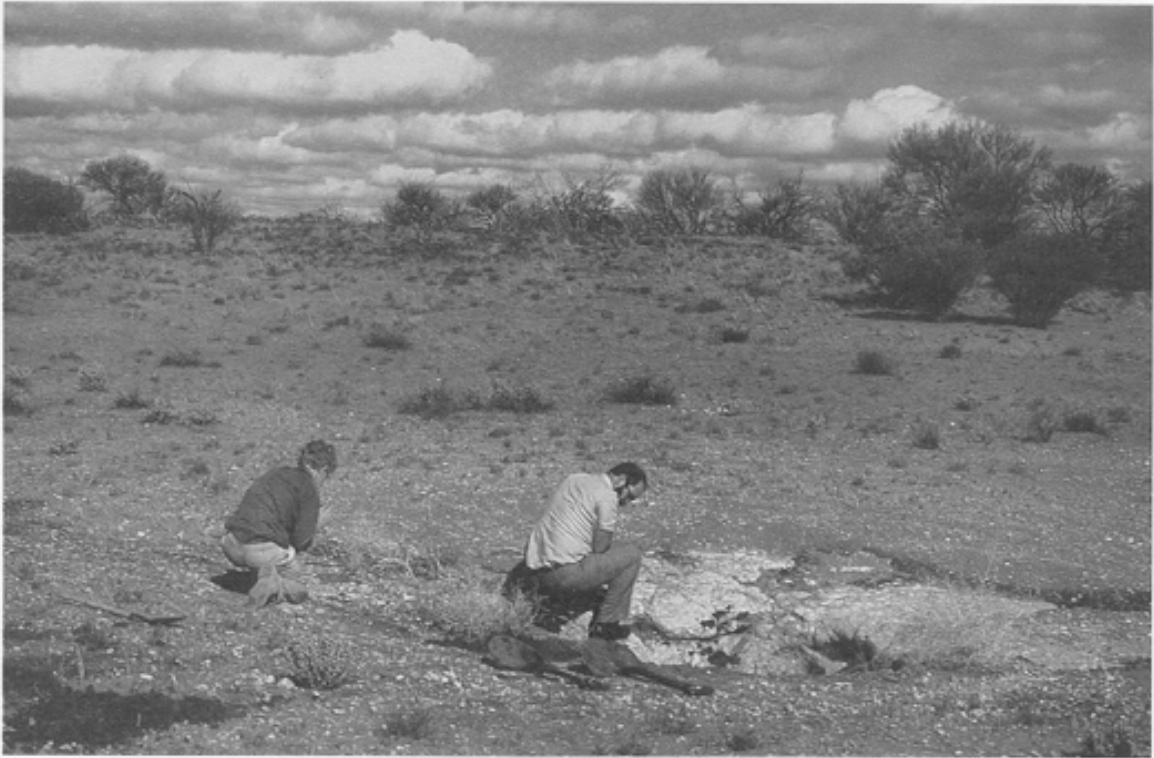
Plate 6. Shell holes. Plate 7. Paling Rockhole of Taranaki

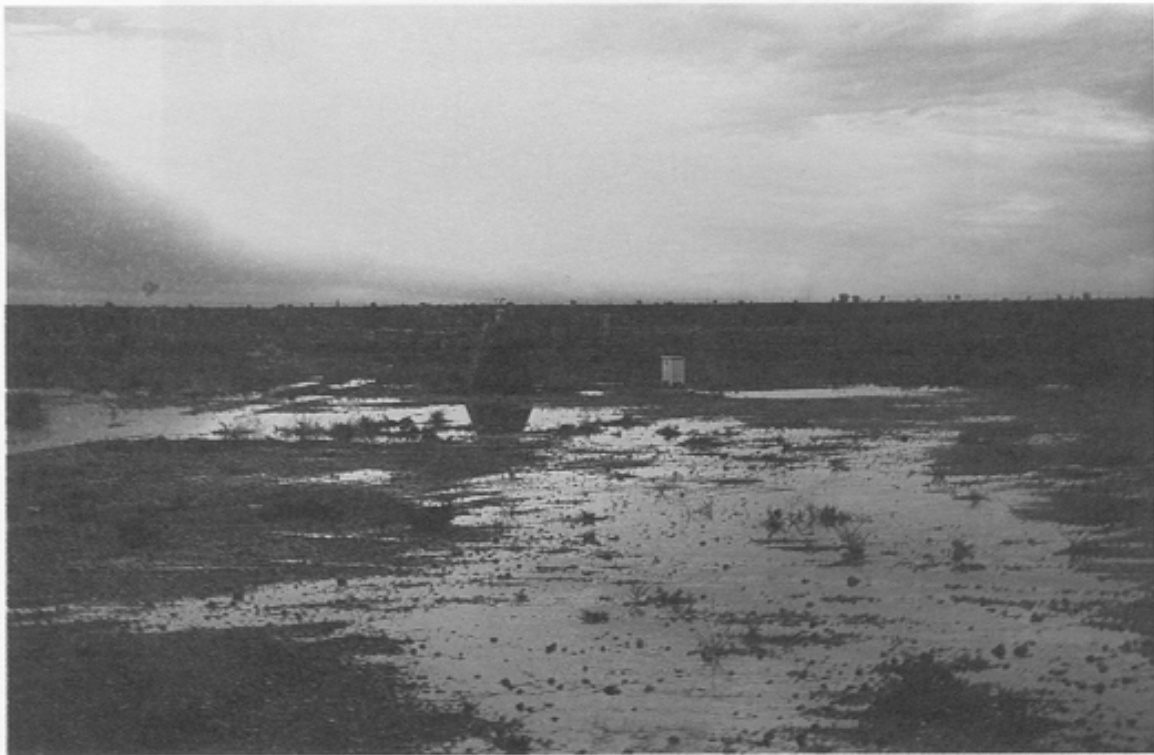
Plate 8. Taranaki danga after a rainstorm

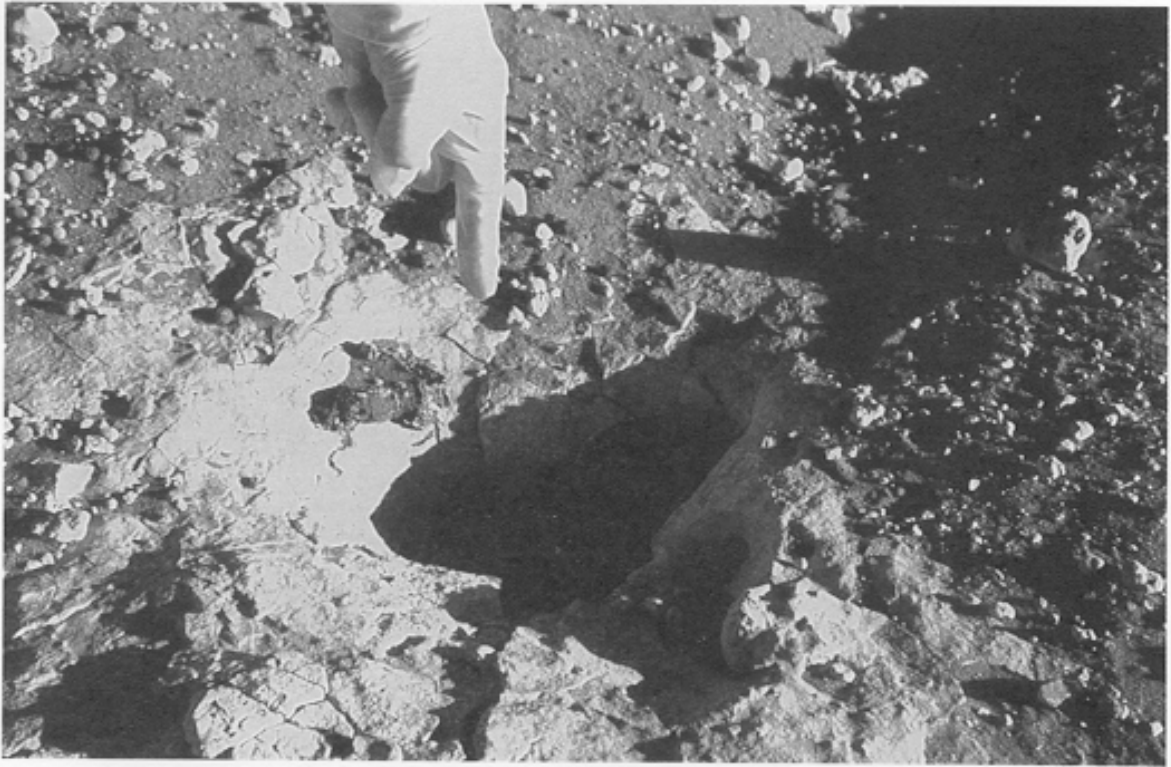
Plate 9. Small solution hole within the man-proof fence at Taranaki

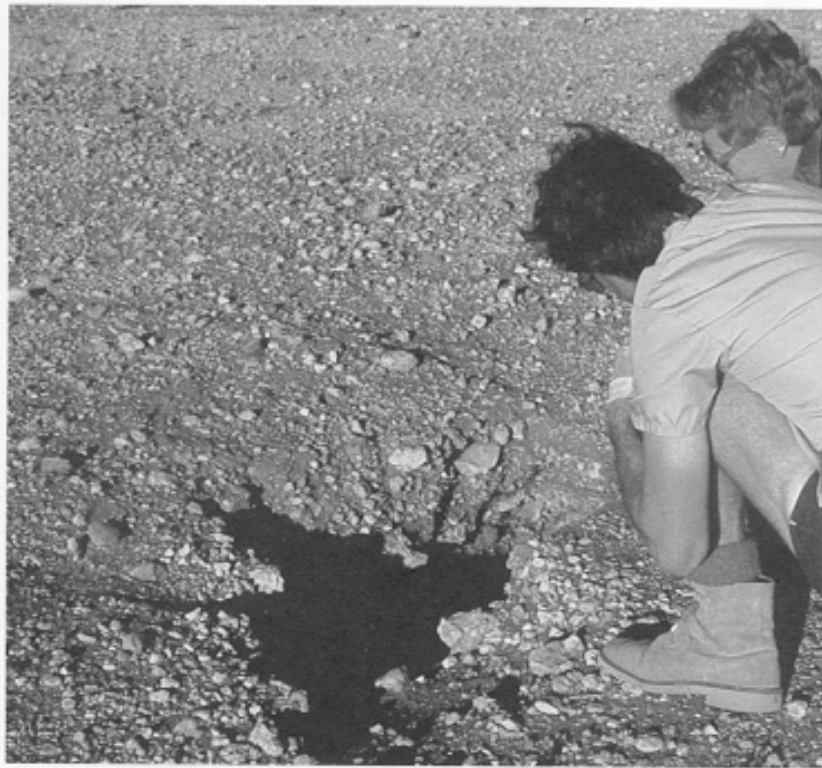
Plate 10. Hole into which water sinks within the man-proof fence
- this hole may have been a rabbit burrow initially
