000(4)(")	
s 22(1)(ii) irrelevant	
	15/3/02 18
_	00
=	143 pr 0
	Need
	1800 FH
	BH RAM GE
	17/3/02 10
	0
	1830 FH40
SPECIAL NOTE TO HIFAR APS	GEN
INSTRUCTIONS FROM DUTY DSC.	16/3/02
A release of fission products occurred today	10/3/CA
at the 823 pond during fuel-rod cropping.	
the area was affected by high radiation dose rates as a result, viz	
dose ratio as a roun, viz	17/2/02
pond ledge level ~ 100 p.Siph AMBIENT	4
pond chest level - 56 pSv/k AMBIENT.  pond Gittration (at wall) ~ 40 mSv/h @ Contact	
Tomorrow the duty Soss will switch Gitration	
to the new ion-column outside B23 ( corner of	
building near GATRI).	
the DSC has requested (ie instructed) the	
duty HIFAR HPS at each shift to monitor	·
the radiation dose rate at these points:	
and ledge labore cropping pond water) level	<b>/</b>
pond ledge (above cropping pond water) level, pond above water at chest level,	<b>/</b>
· wall fittration equipment,	16:3:02
· external ion column,	0030

Due to the design of facility ponds and buildings, small birds periodically enter the confines of the facilities. Because the pond water contained relatively minor levels of radioactivity, this was not a concern over the years. In March of 2002

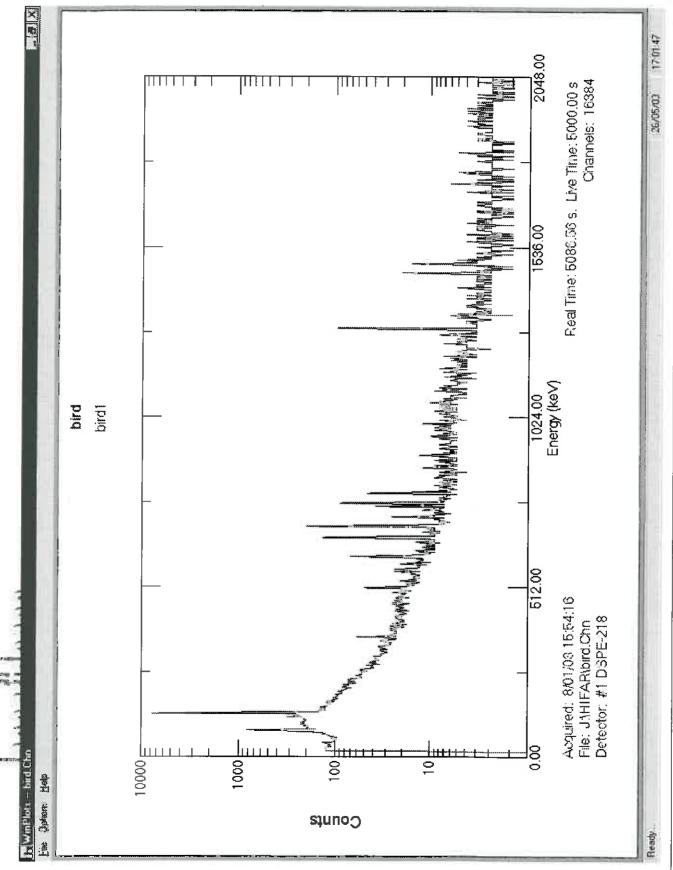
No accurate geometric efficiency is available for assay. Detector Efficiency has been used for 10 ml vial. \*

The presence of the mixed fission products indicated that the birds had been in contact with the contaminated pond. It was noted that Bird No.1 showed higher levels of contamination than Bird No.2 As there was no accurate efficiency data available for the analysis (due to the abnormal geometry), estimations of activities present in Bird No.1 have been made on the efficiency curve obtained from of a 10ml vial. A summary of the estimations of the total activity present (internal & external) are presented in Table 1 and the calculations are available in Table 2.

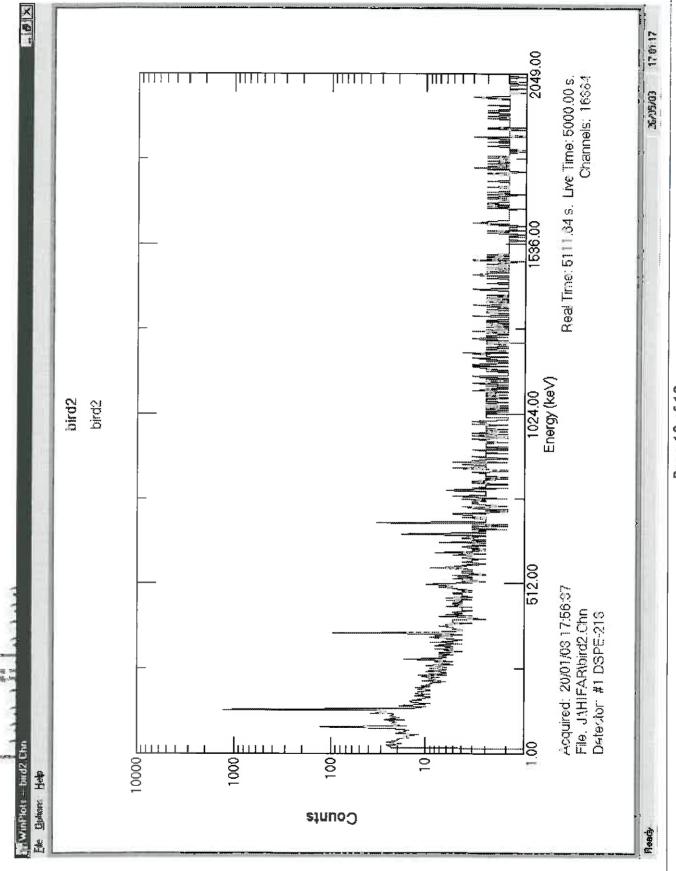
Detector #1 ACQ 20-Jan-2003 at 17:56:37 RT = 5111.6 LT = 5000.0 DSPE-218 bird2 ROI # 1 RANGE: 627 = 79.41 keV to 655 = 82.90 keVAREA : Gross = 1288 Net = 925 +/- 48CENTROID: 641.63 = 81.23 keVSHAPE: FWHM = 0.76 FW (1/5)M = 1.47ID: Ce-144 at 80.12keV Corrected Rate = 11.56 +/- 0.60 cA RANGE: 1053 = 132.51keV to 1083 = 136.25keV ROI # 2 AREA : Gross = 12118 Net = 11405 +/- 119CENTROID: 1068.88 = 134.49 keVSHAPE: FWHM = 1.04 FW (1/5) M = 1.64ID: Ce-144 at 133.53keV Corrected Rate = 21.12 +/- 0.22 cA RANGE: 1150 = 144.61 keV to 1180 = 148.35 keVROI # 3 AREA: Gross = 220 Net = 80 +/- 25 CENTROID: 1166.87 = 146.71 keVSHAPE: FWHM = 0.48 FW (1/5)M = 0.67ID: Ce-141 at 145.45keV Corrected Rate = 0.03 + / - 0.01 cA ROI # 4 RANGE: 2255 = 282.41keV to 2289 = 286.65keV AREA : Gross = 166 Net = 43 +/- 25CENTROID: 2277.89 = 285.27 keVSHAPE: FWHM = 0.16 FW(1/5)M = 0.78No close library match. ROI # 5 RANGE: 2897 = 362.50keV to 2933 = 366.99keV AREA : Gross = 1009 Net = 886 + /- 39CENTROID: 2914.40 = 364.67 keVSHAPE: FWHM = 1.24FW(1/5)M = 2.00ID: I-131 at 364.48keV Corrected Rate = 0.22 + / - 0.01 cA ROI # 6 RANGE: 3192 = 399.31keV to 3228 = 403.80keV AREA : Gross = 72 Net = -8 +/- 20 CENTROID: 3200.00 = 400.30 keVSHAPE: FWHM = 1.40 FW(1/5)M = 1.52No close library match. RANGE: 3547 = 443.60keV to 3583 = 448.10keV ROI # 7 AREA : Gross = 49 Net = 0 +/- 15 CENTROID: 3564.70 = 445.81 keVSHAPE: FWHM = 0.31 FW(1/5)M = 0.43ID: Ba-140 at 437.55keV Corrected Rate = 0.00 + / - 0.19 cA ROI # 8 RANGE: 4484 = 560.55 keV to 4524 = 565.55 keV+/- 17 AREA: Gross = 57 Net = 2 CENTROID: 4506.14 = 563.32 keVSHAPE: FWHM = 0.18 FW(1/5)M = 0.31ID: Cs-134 at 563.26keV Corrected Rate = 0.00 + / - 0.04 cA
